Navajo Abandoned Uranium Mine

Site Screen Report

Rocky Flats No. 1 AUM Site

Weston Solutions, Inc.

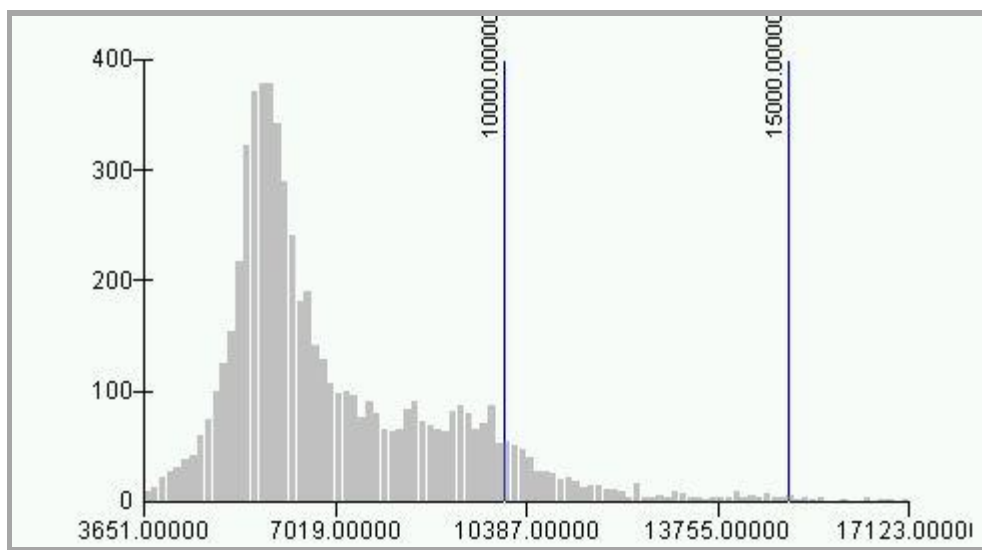
The following chart and statistics were generated by ESRI ArcGIS 9.3.1, and show the general distribution of the site gamma radiation measurements. The horizontal X axis represents the gamma radiation reading levels in cpm (lowest levels to the left). The vertical Y axis represents the frequency of each gamma radiation level.

Count:	6207
Minimum:	3651.00000
Maximum:	17123.00000
Sum:	43464230.00000
Mean:	7002.45368
Median:	6268.00000
Standard Deviation:	1974.61118

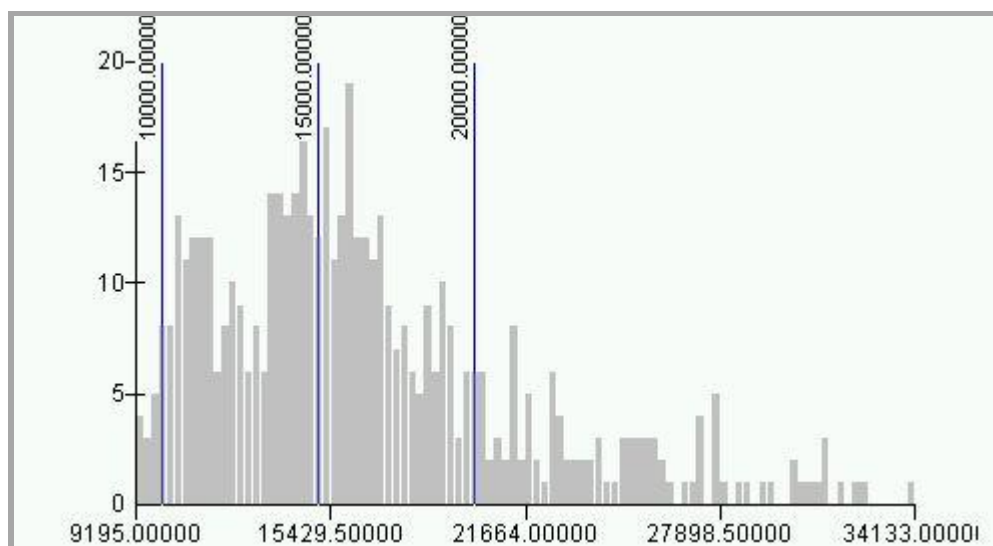
The following chart and statistics were generated by ESRI ArcGIS 9.3.1, and show the general distribution of the site gamma radiation measurements. The horizontal X axis represents the gamma radiation reading levels in cpm (lowest levels to the left). The vertical Y axis represents the frequency of each gamma radiation level.

Count:	530
Minimum:	9195.00000
Maximum:	34133.00000
Sum:	8762651.00000
Mean:	16533.30377
Median:	15612.50000
Standard Deviation:	4904.45764

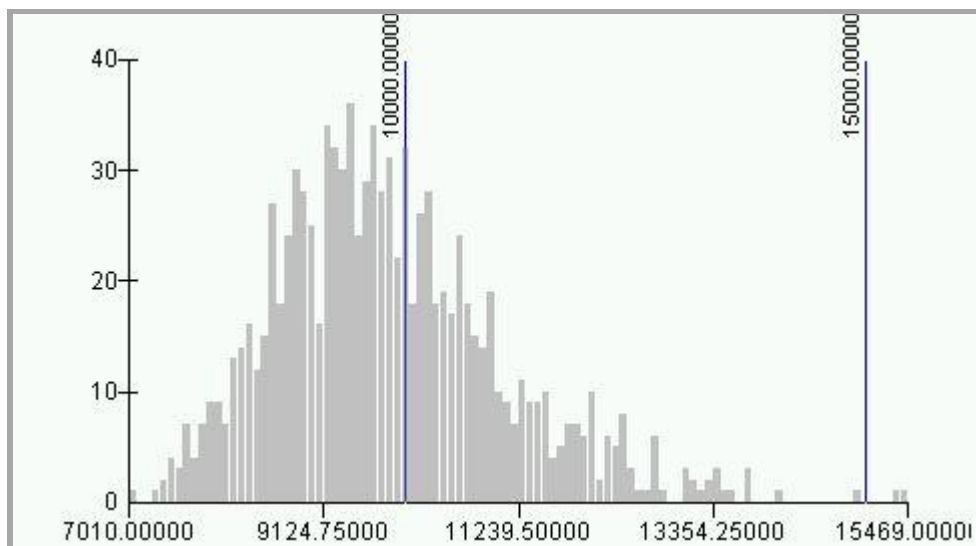
The following chart and statistics were generated by ESRI ArcGIS 9.3.1, and show the general distribution of the site gamma radiation measurements. The horizontal X axis represents the gamma radiation reading levels in cpm (lowest levels to the left). The vertical Y axis represents the frequency of each gamma radiation level.

Count:	997
Minimum:	7010.00000
Maximum:	15469.00000
Sum:	9810896.00000
Mean:	9840.41725
Median:	9692.00000
Standard Deviation:	1247.25914

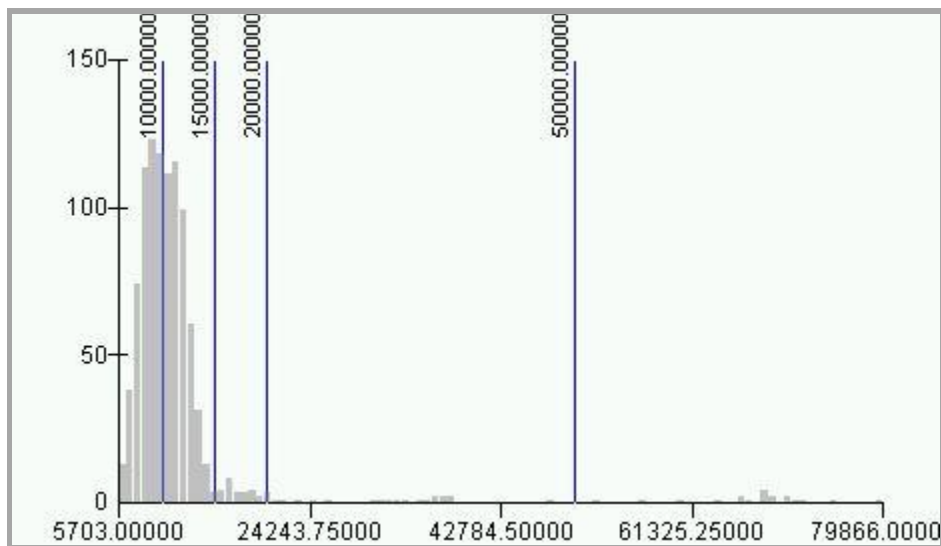
The following chart and statistics were generated by ESRI ArcGIS 9.3.1, and show the general distribution of the site gamma radiation measurements. The horizontal X axis represents the gamma radiation reading levels in cpm (lowest levels to the left). The vertical Y axis represents the frequency of each gamma radiation level.

Count:	1002
Minimum:	5703.00000
Maximum:	79866.00000
Sum:	11789585.00000
Mean:	11766.05289
Median:	10132.50000
Standard Deviation:	8690.54103

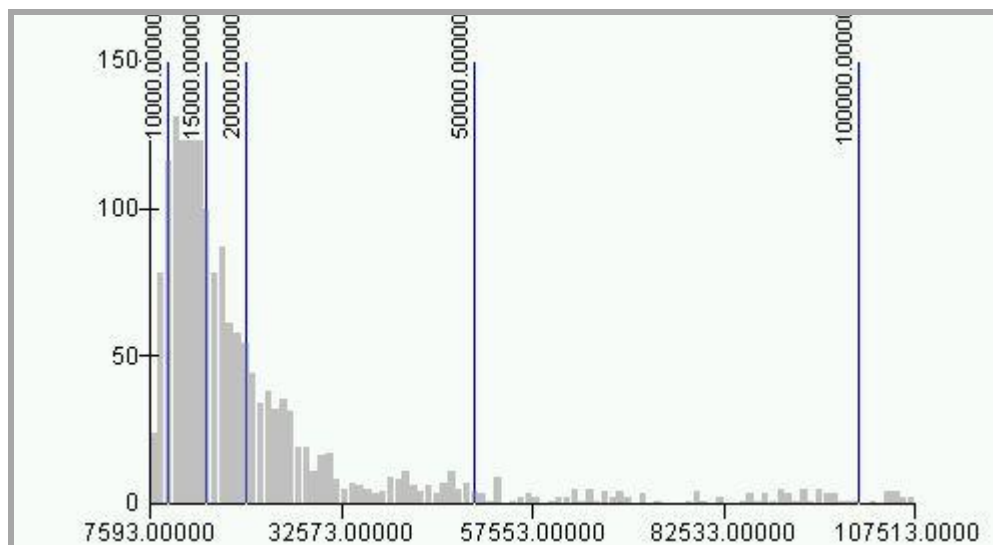
The following chart and statistics were generated by ESRI ArcGIS 9.3.1, and show the general distribution of the site gamma radiation measurements. The horizontal X axis represents the gamma radiation reading levels in cpm (lowest levels to the left). The vertical Y axis represents the frequency of each gamma radiation level.

Count:	1723
Minimum:	7593.00000
Maximum:	107513.00000
Sum:	37545105.00000
Mean:	21790.54266
Median:	15609.00000
Standard Deviation:	17656.28549

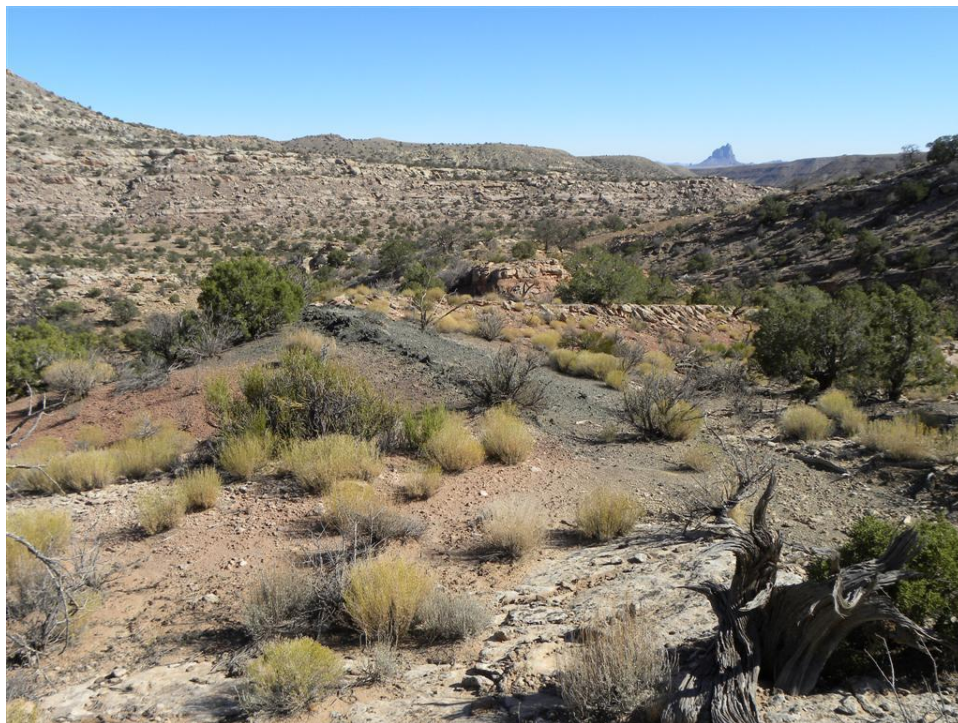
A 150' x 150' reclamation cap at center of the site

Photo 1. Mine site #265

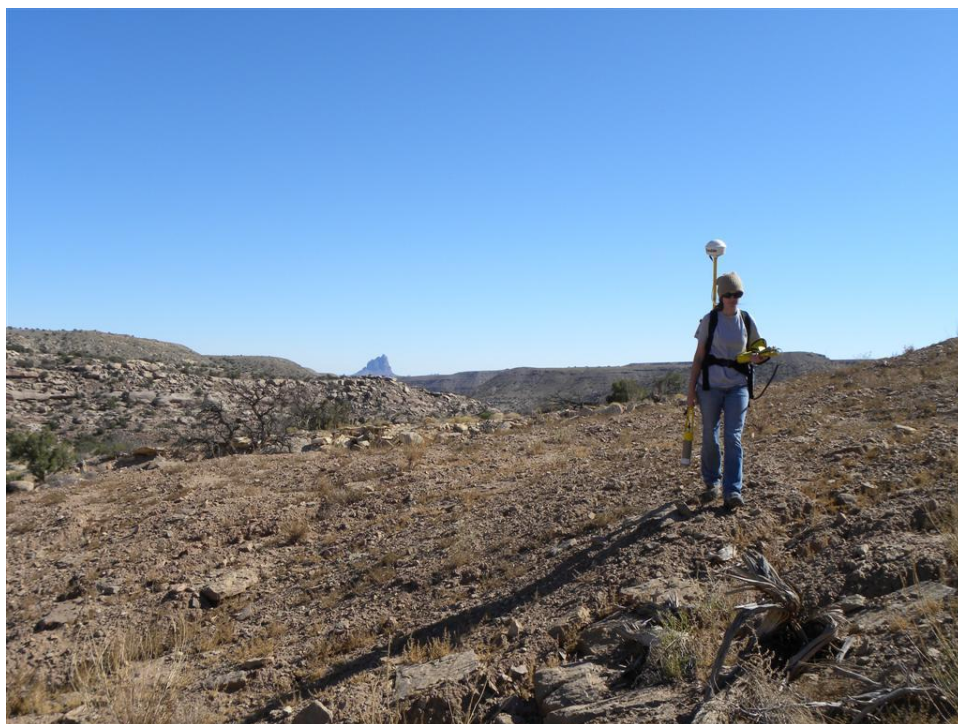
Photo 2. Mine site #266 reclamation cap area

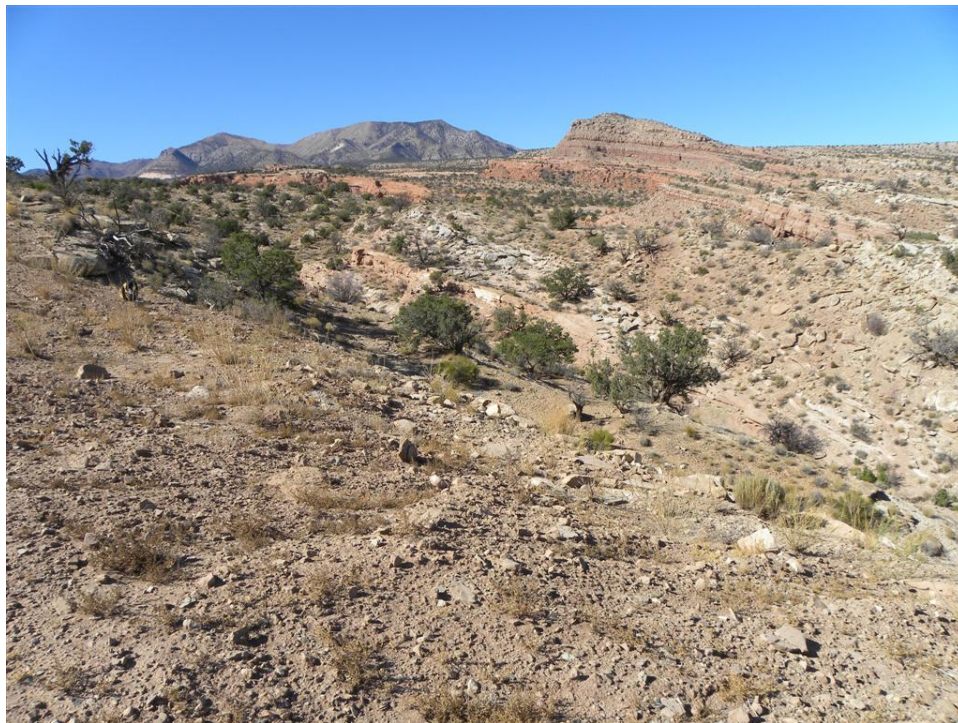
Photo 3. Mine site #266

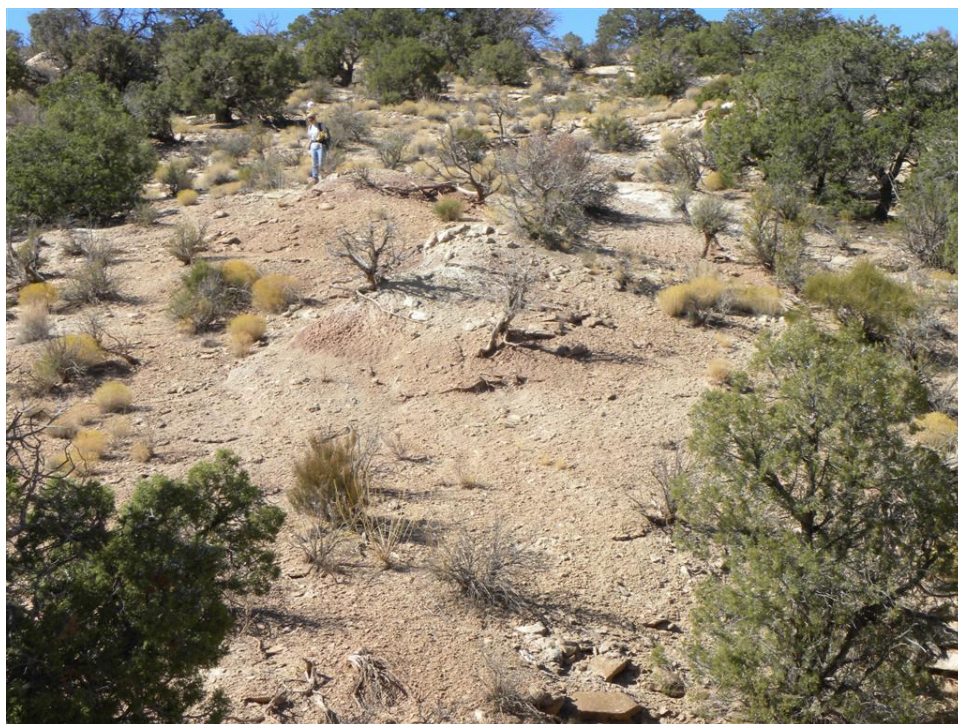
Photo 4. Mine site #267

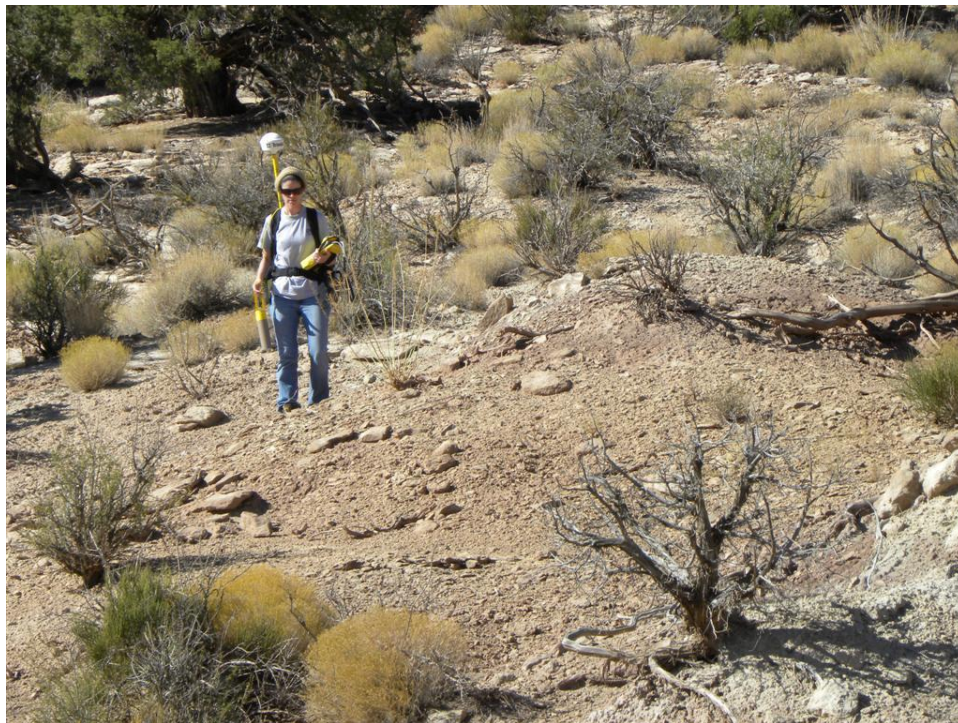
Photo 5. Mine site #268

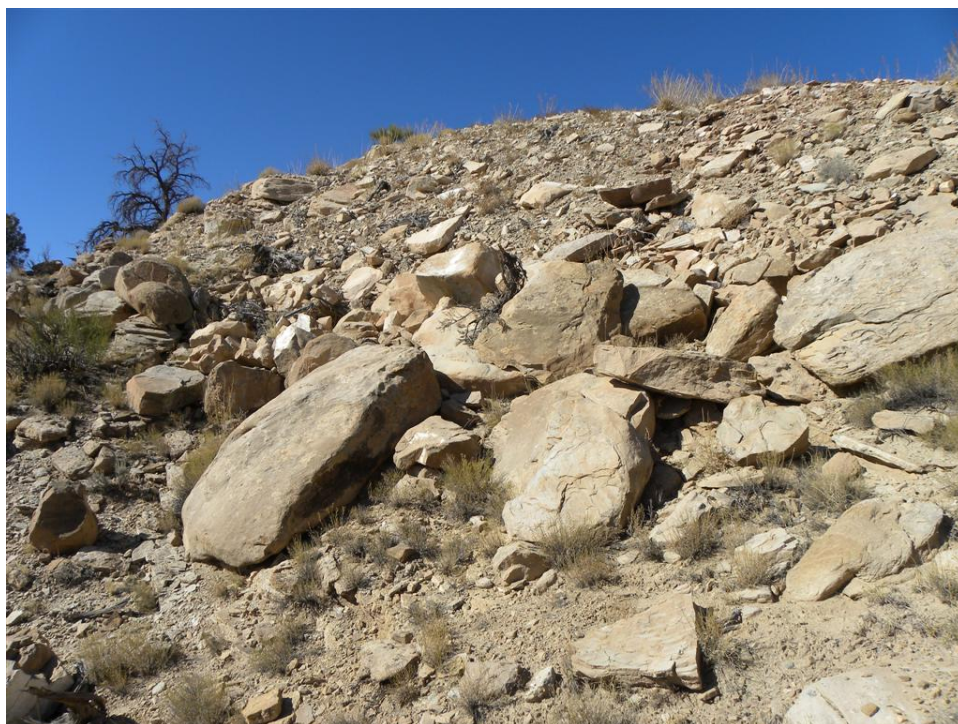
1 possible collapsed adit

A small waste debris pile at entrance to the adit

Photo 6. Mine site #269 collapsed adit and waste pile

Waste pile and possible collapsed adit found at site #269; reclamation cap found at site #266

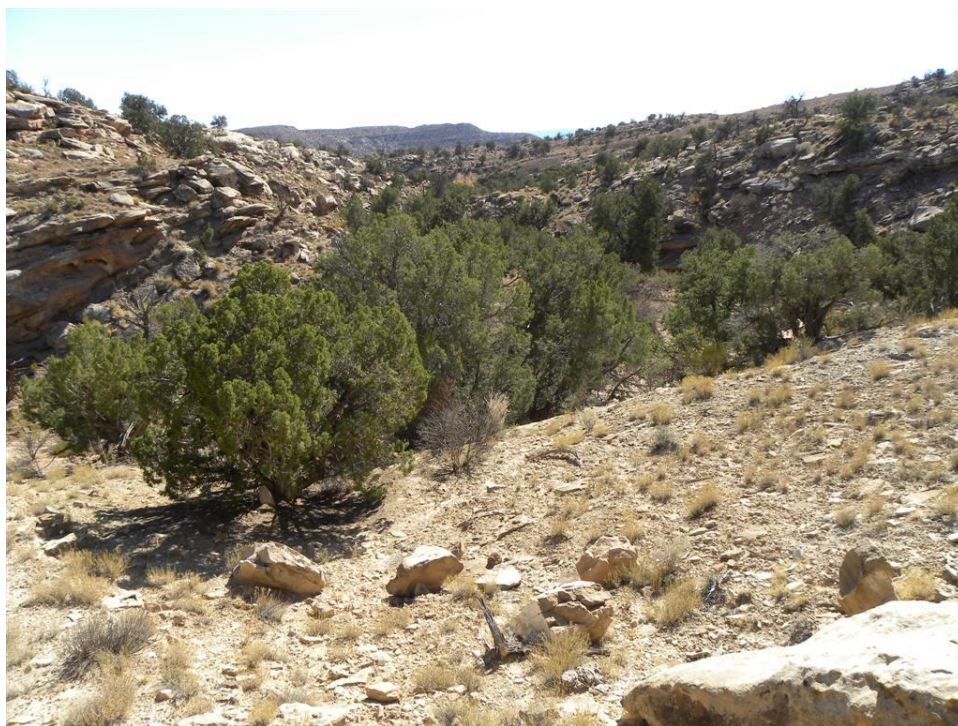
Photo 7. Mine site #269

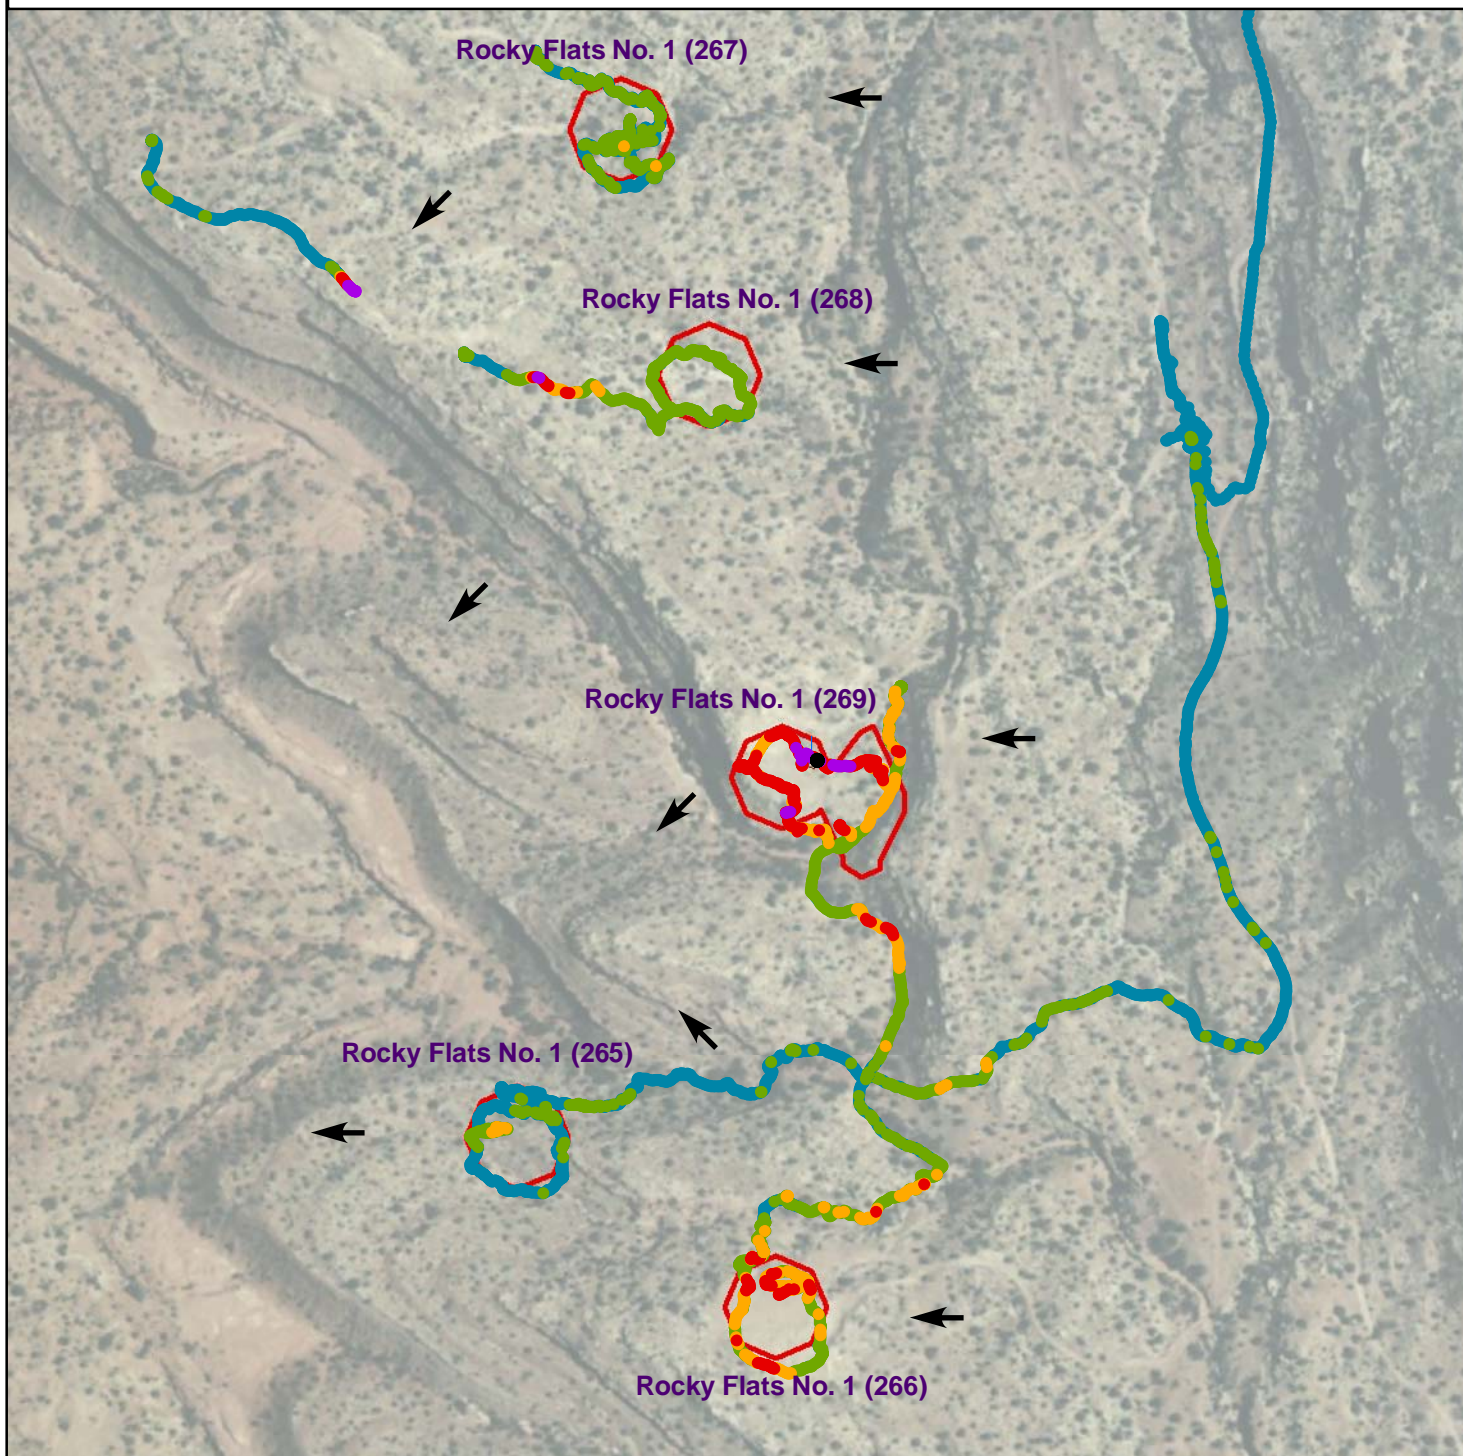
**Figure 1 - Gamma Radiation Measurements
Rocky Flats No.1 Mines (265, 266, 267, 268, 269)
Navajo Nation, Arizona**

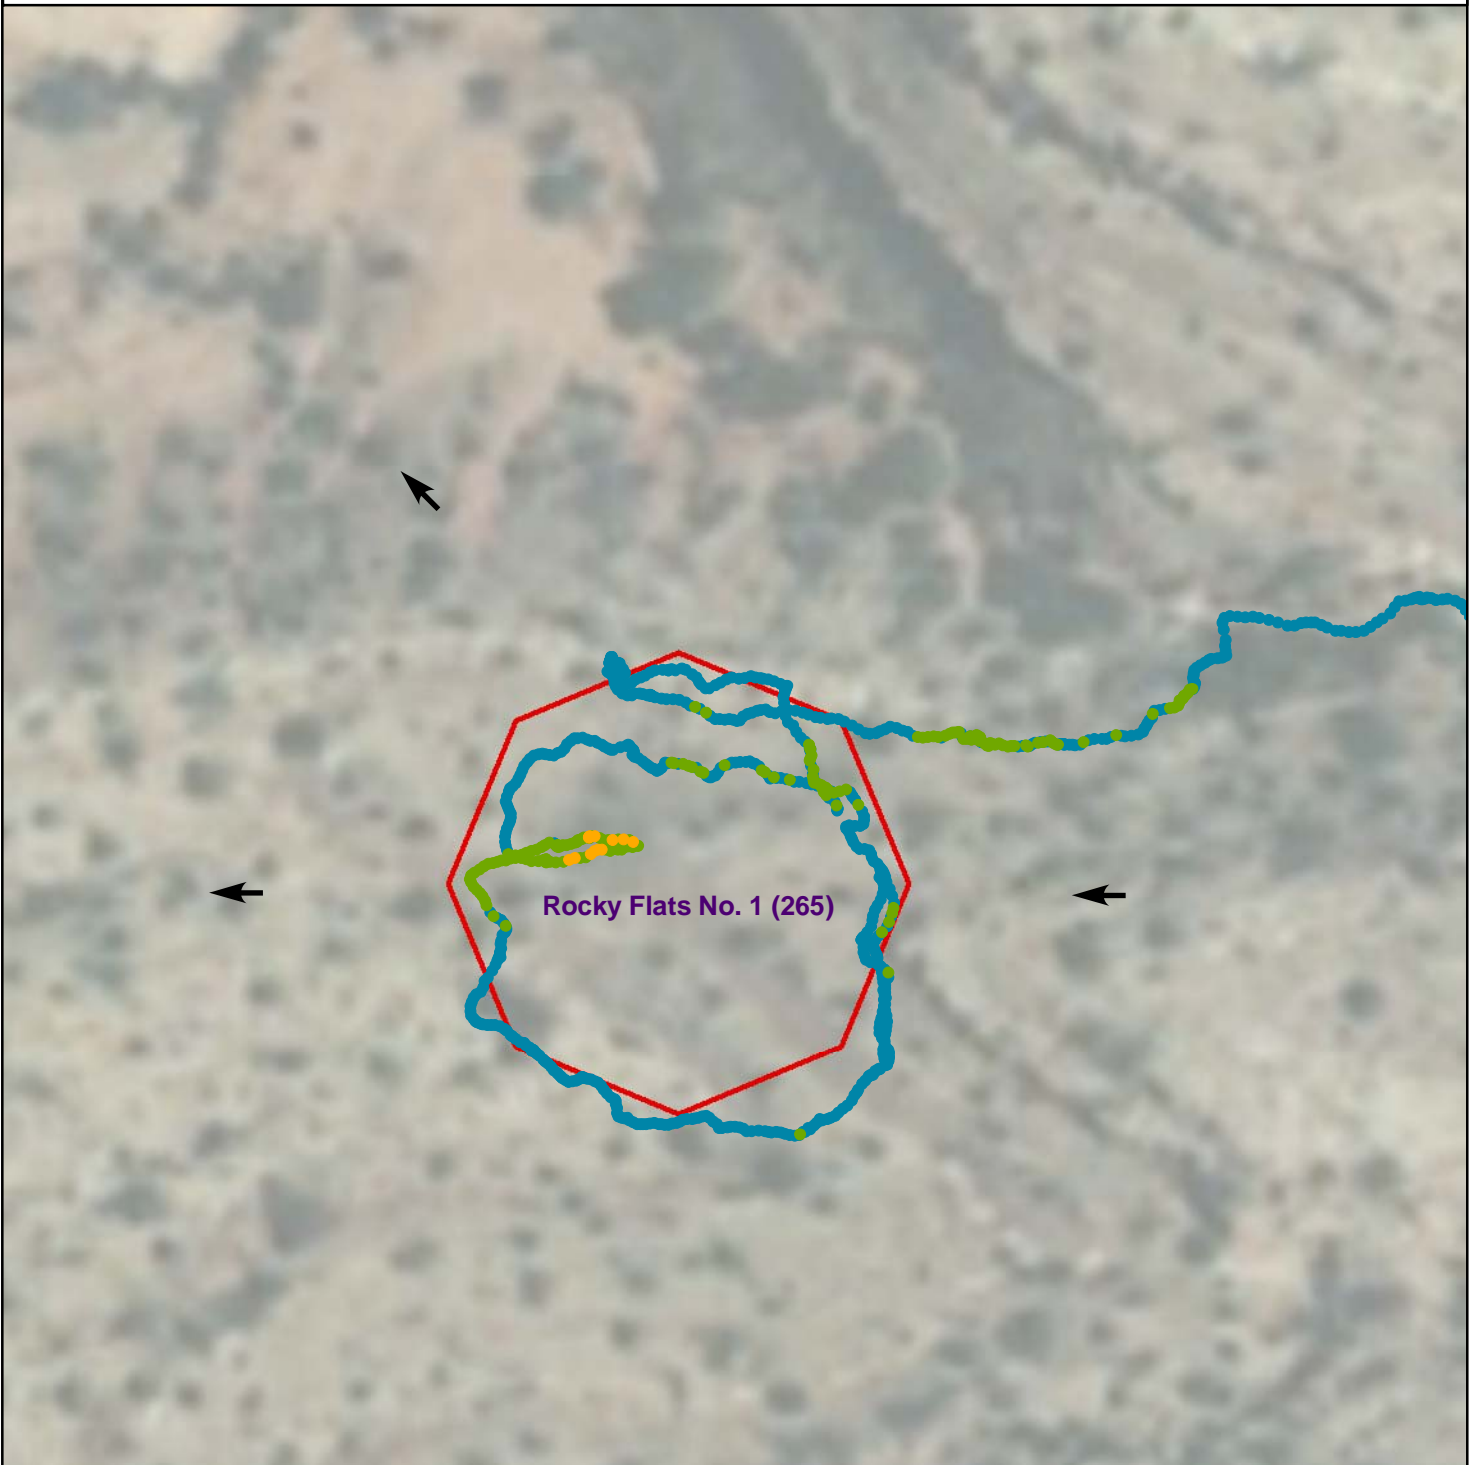
A total of 6,207 gamma radiation measurements were collected from the mine site, ranging from 3,651 cpm to 17,123 cpm. The measurements are represented in Figures 2 and 3.

Figure 3 - Gamma Radiation Measurements
Rocky Flats No. 1 (265)
Beclabito Chapter, Navajo Nation, Arizona

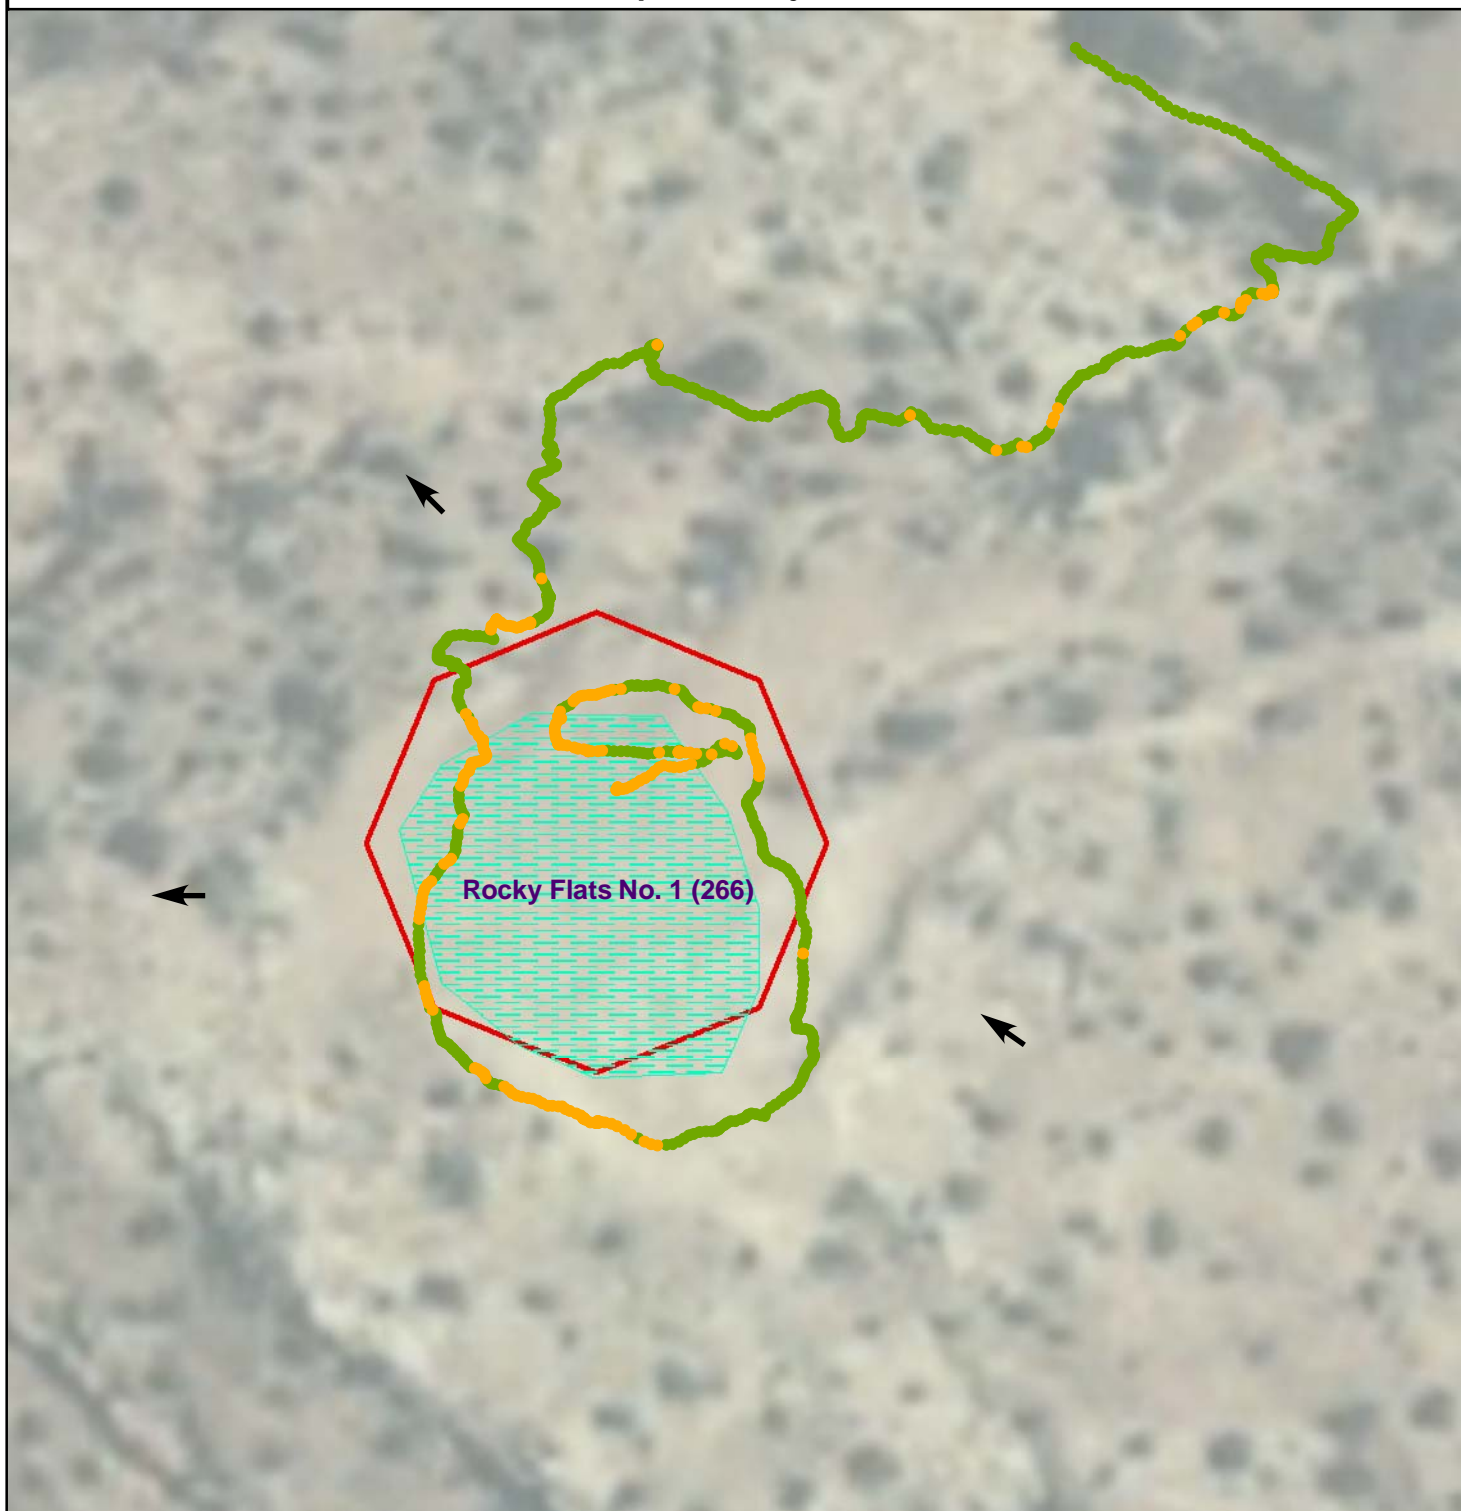
A total of 530 gamma radiation measurements were collected from the mine site, ranging from 9,195 cpm to 34,133 cpm. Measurements collected at the reclamation cap were found at levels above 30,000 cpm. The measurements are represented in Figures 4 and 5.

**Figure 4 - Gamma Radiation Measurements, Above Two Times Background
Rocky Flats No. 1 (266)
Beclabito Chapter, Navajo Nation, Arizona**

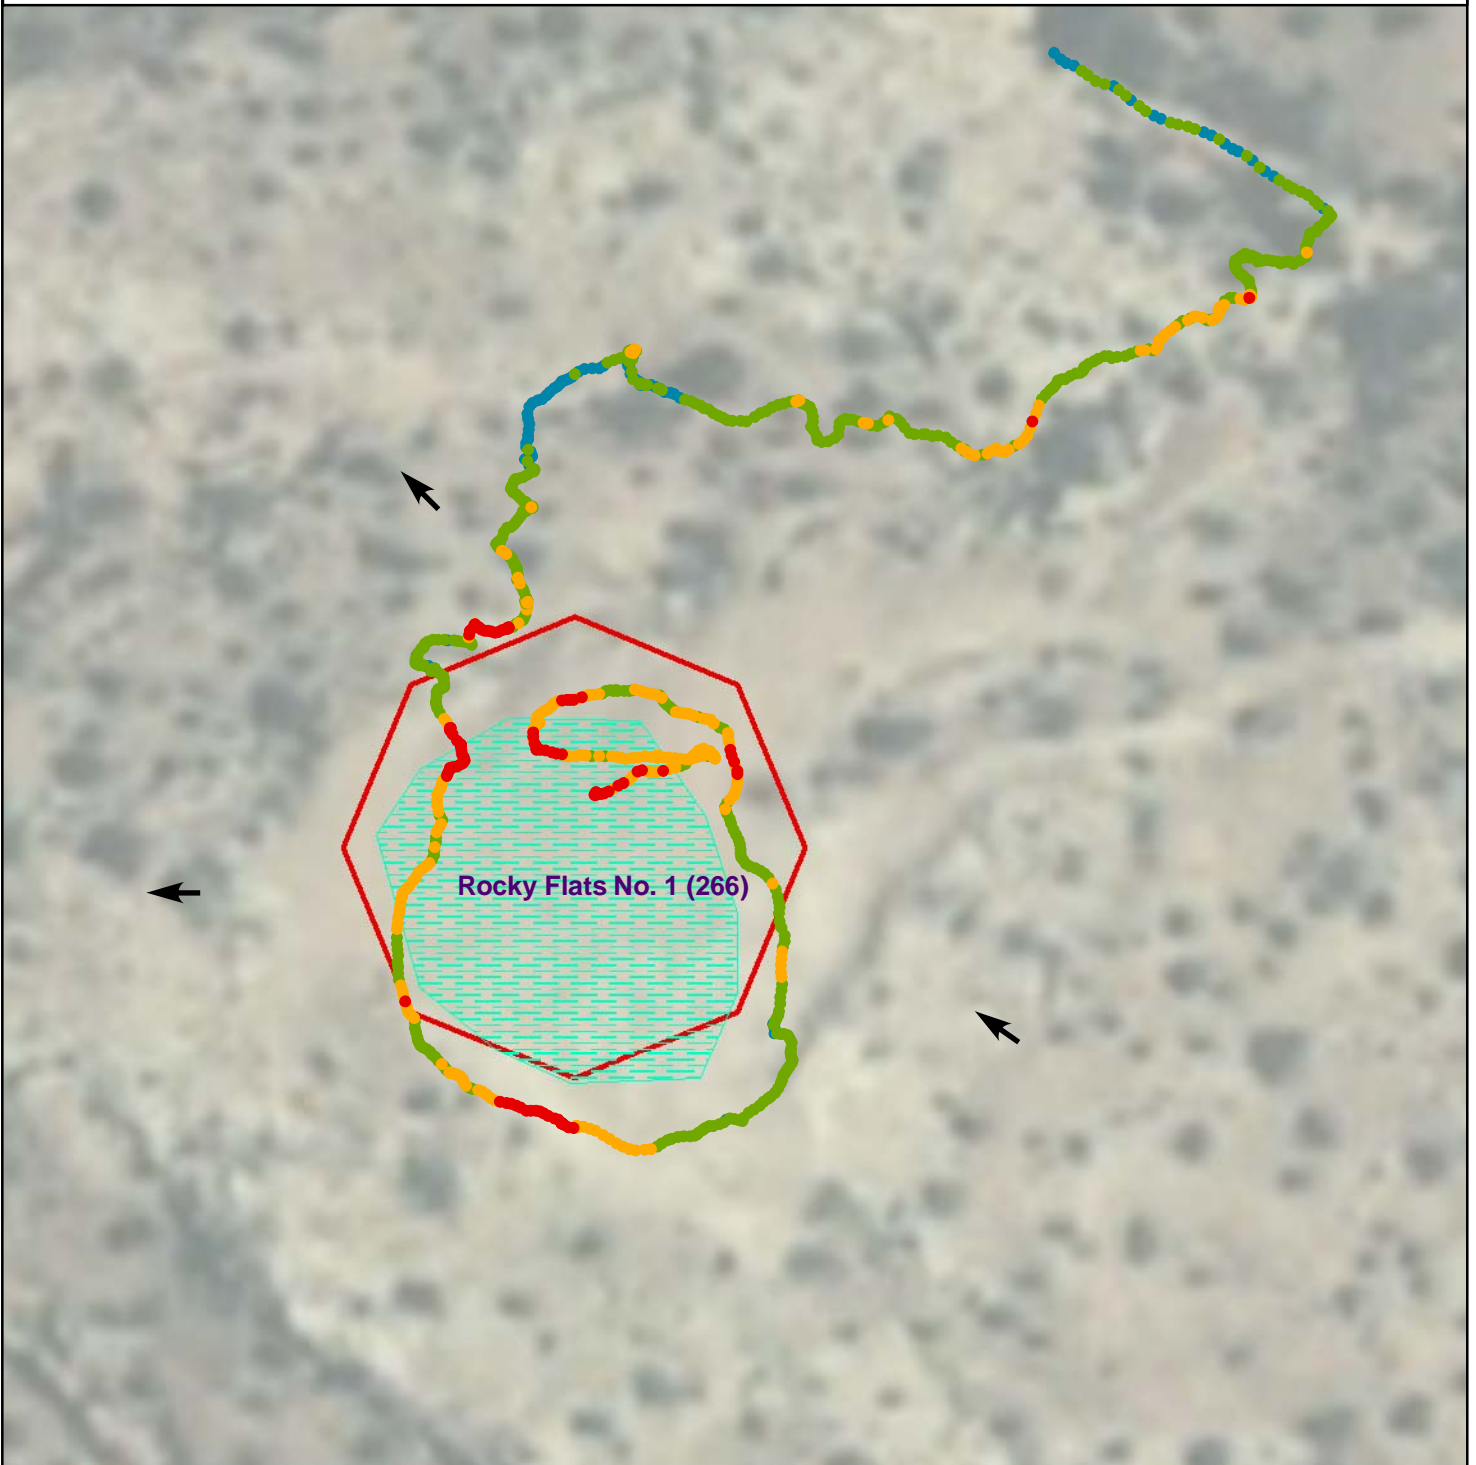
Figure 5 - Gamma Radiation Measurements
Rocky Flats No. 1 (266)
Beclabito Chapter, Navajo Nation, Arizona

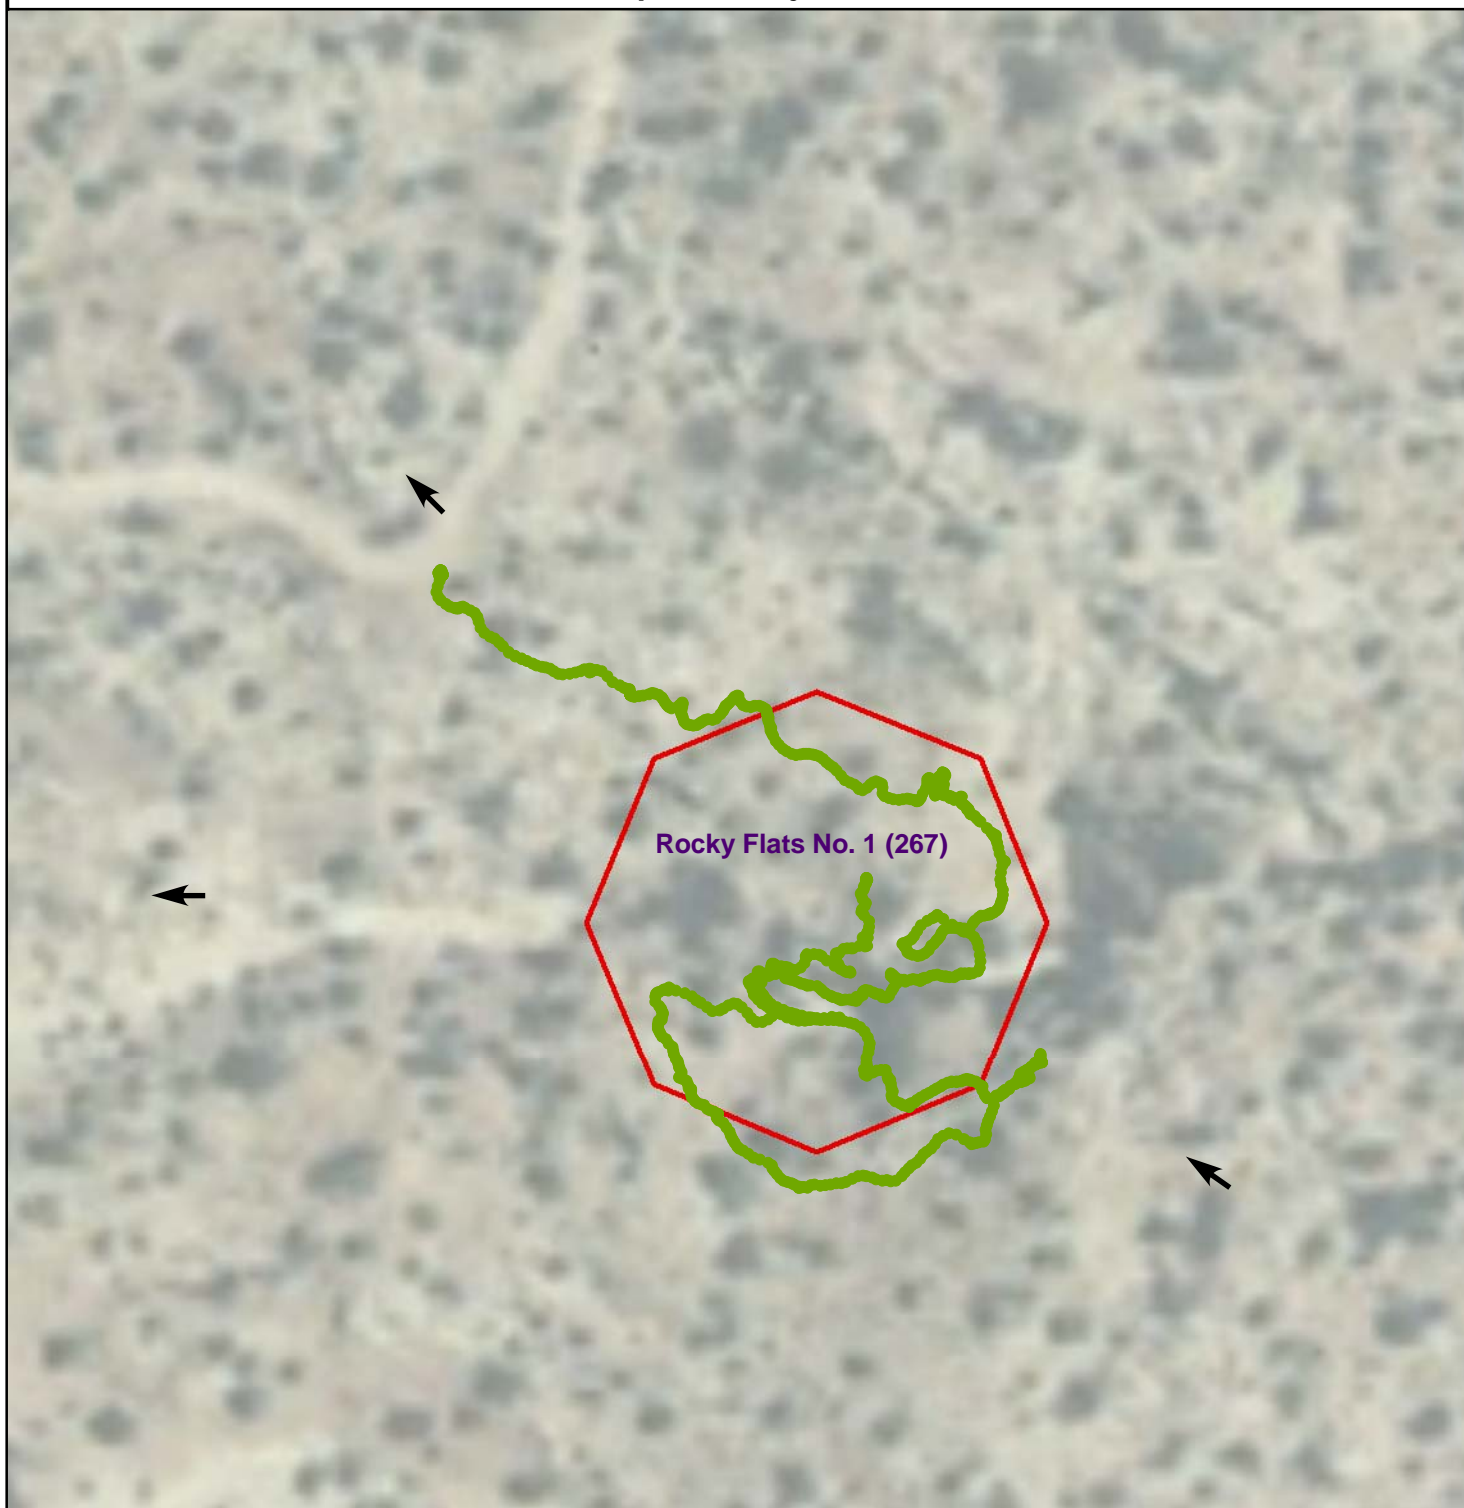
A total of 997 gamma radiation measurements were collected from the mine site, ranging from 7,010 cpm to 15,469 cpm. The measurements are represented in Figures 6 and 7.

**Figure 6 - Gamma Radiation Measurements, Above Two Times Background
Rocky Flats No. 1 (267)
Beclabito Chapter, Navajo Nation, Arizona**

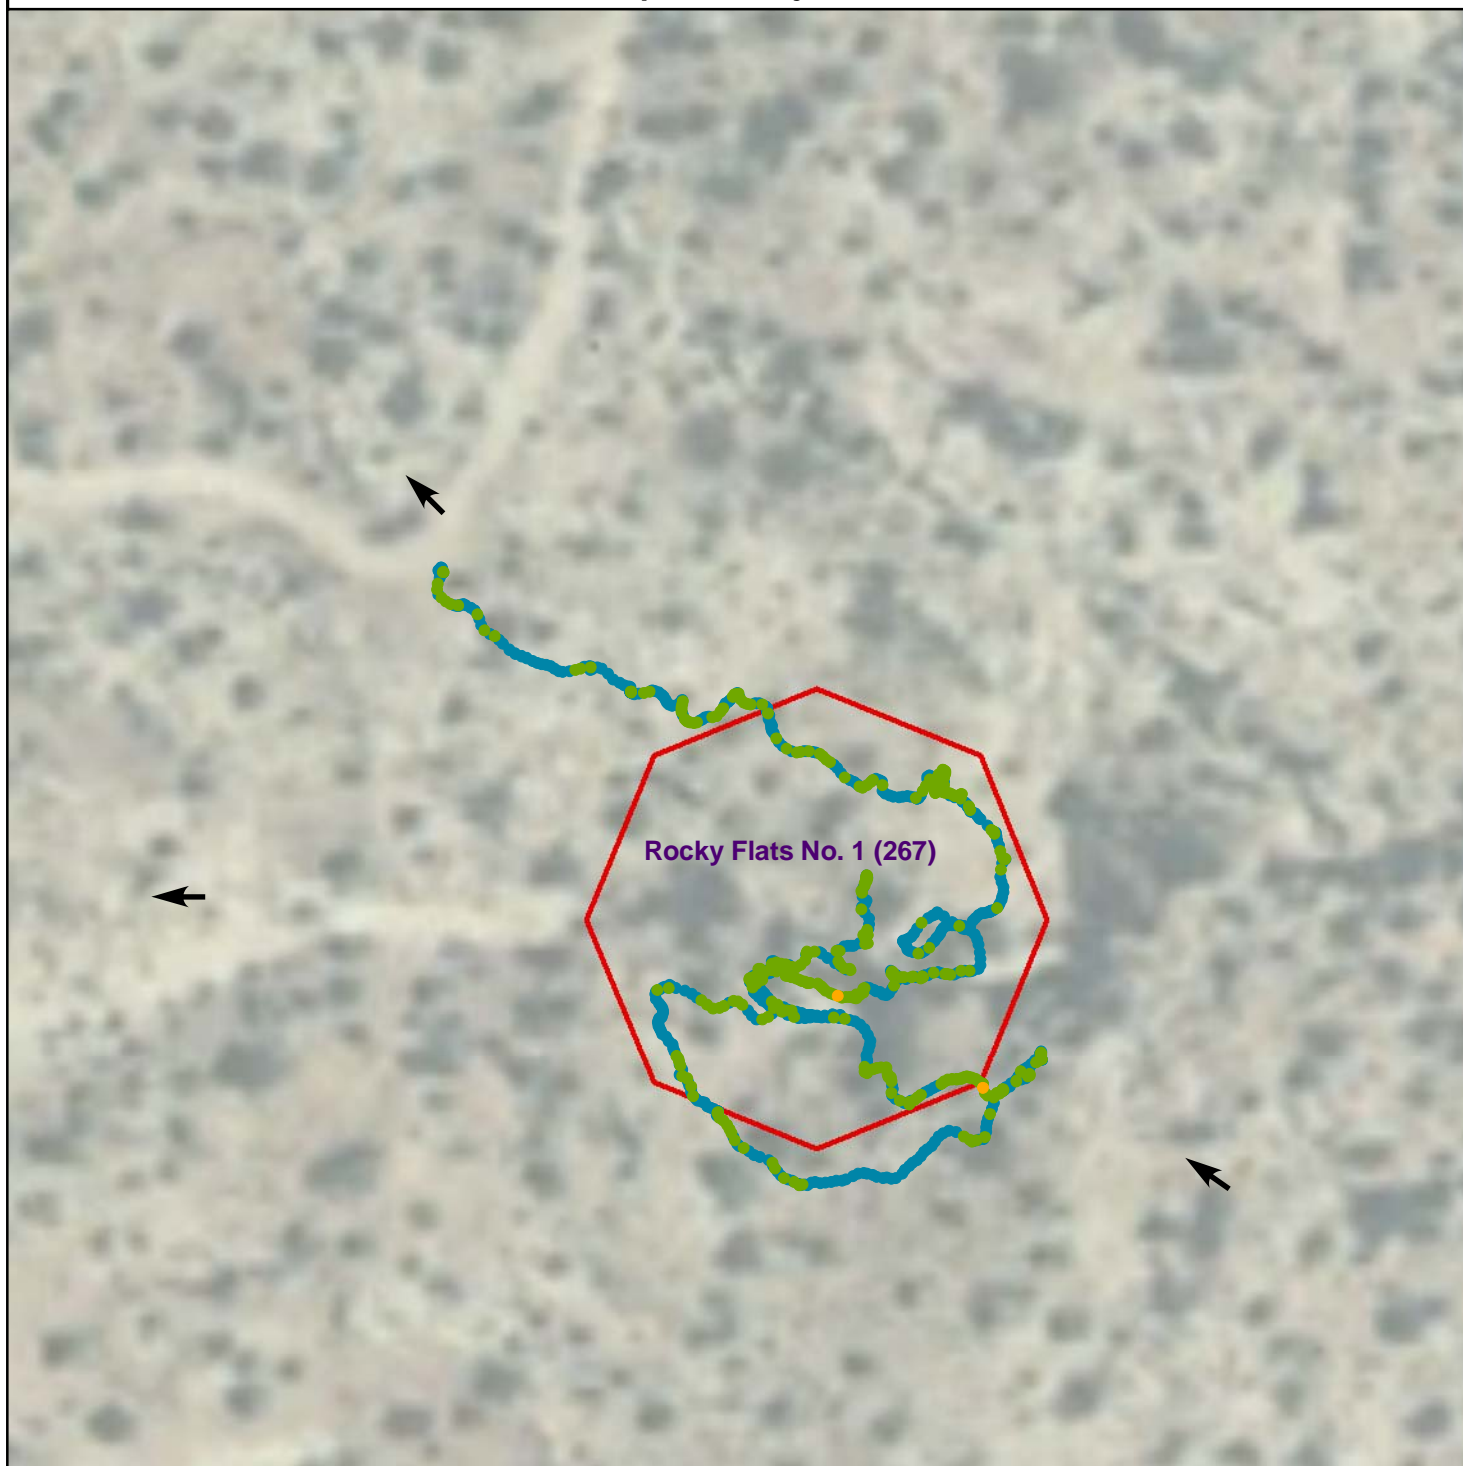
Figure 7 - Gamma Radiation Measurements
Rocky Flats No. 1 (267)
Beclabito Chapter, Navajo Nation, Arizona
